Date : 8/15/2023

SERVICE TECHNICAL INSTRUCTION

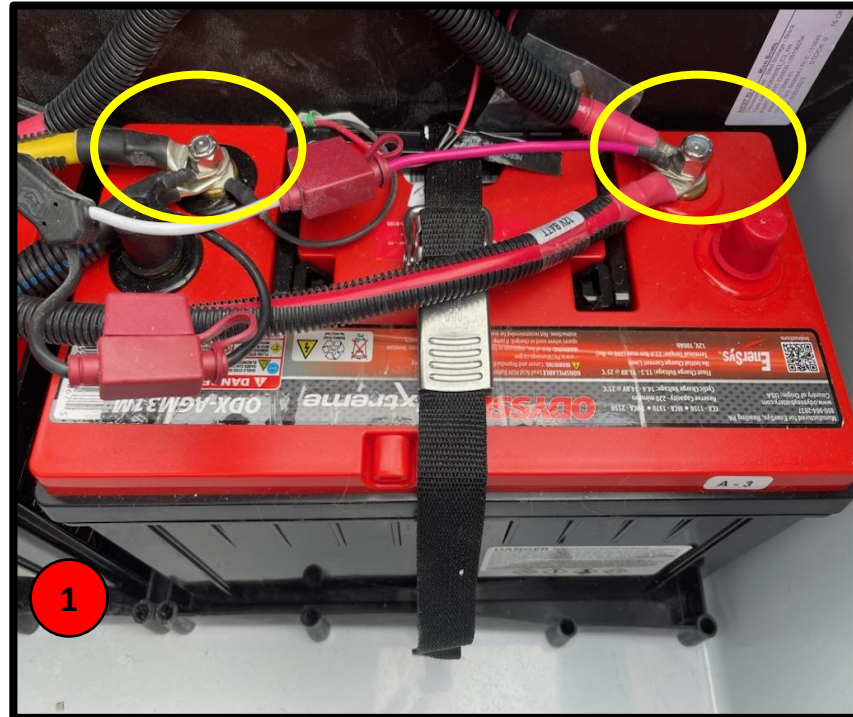
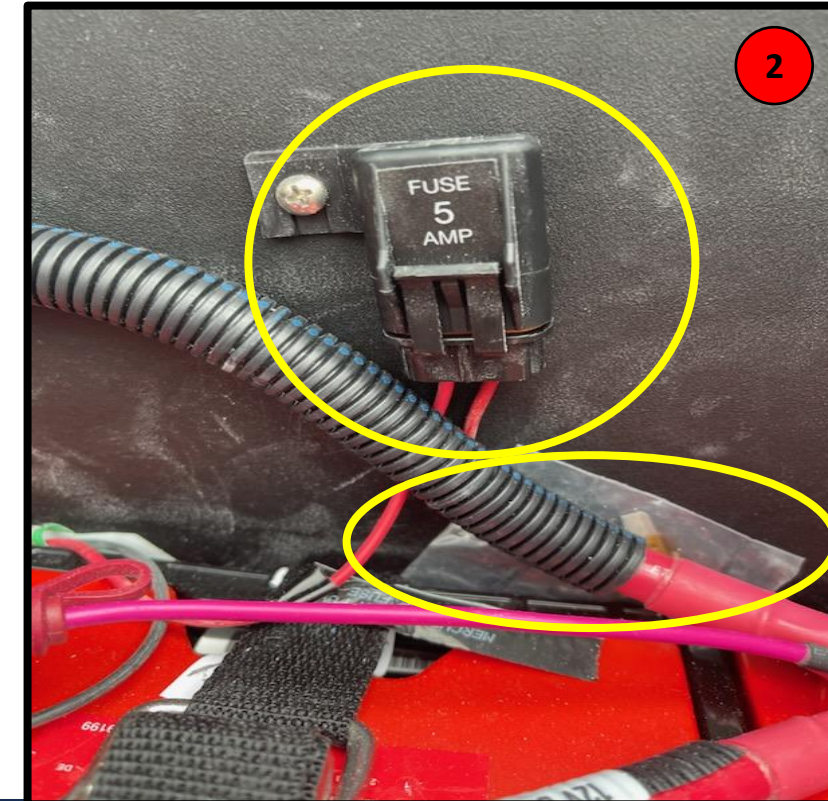
- If you lose function of your Trim, Key power (beep) at the switch, and Cranking ability.
- **1. Check the following:**
- Clean Battery Terminals
- Tight Battery Connections
- No Exposed Wires
- **2. Check the Clean Power Fuse** located on the STBD side above the Cranking Battery
- This is a 5 AMP Fuse that is easily accessible and easy to change
- A Replacement fuse should be Zip Tied right below the Fuse Housing
- **After the Fuse is changed, Verify:**
- Power to the Trim
- “Beep” when you turn the Key
- You will now have Cranking Ability to the Engine
